**NASA CONTRACTOR  
REPORT**

NASA CR-2884

**LOAN COPY: RETURN TO  
AFWL TECHNICAL LIBRARY  
KIRTLAND AFB, N. M.****MODEL PREDICTIONS OF WIND  
AND TURBULENCE PROFILES  
ASSOCIATED WITH AN ENSEMBLE  
OF AIRCRAFT ACCIDENTS**

AERONAUTICAL RESEARCH ASSOCIATES OF PRINCETON, INC.

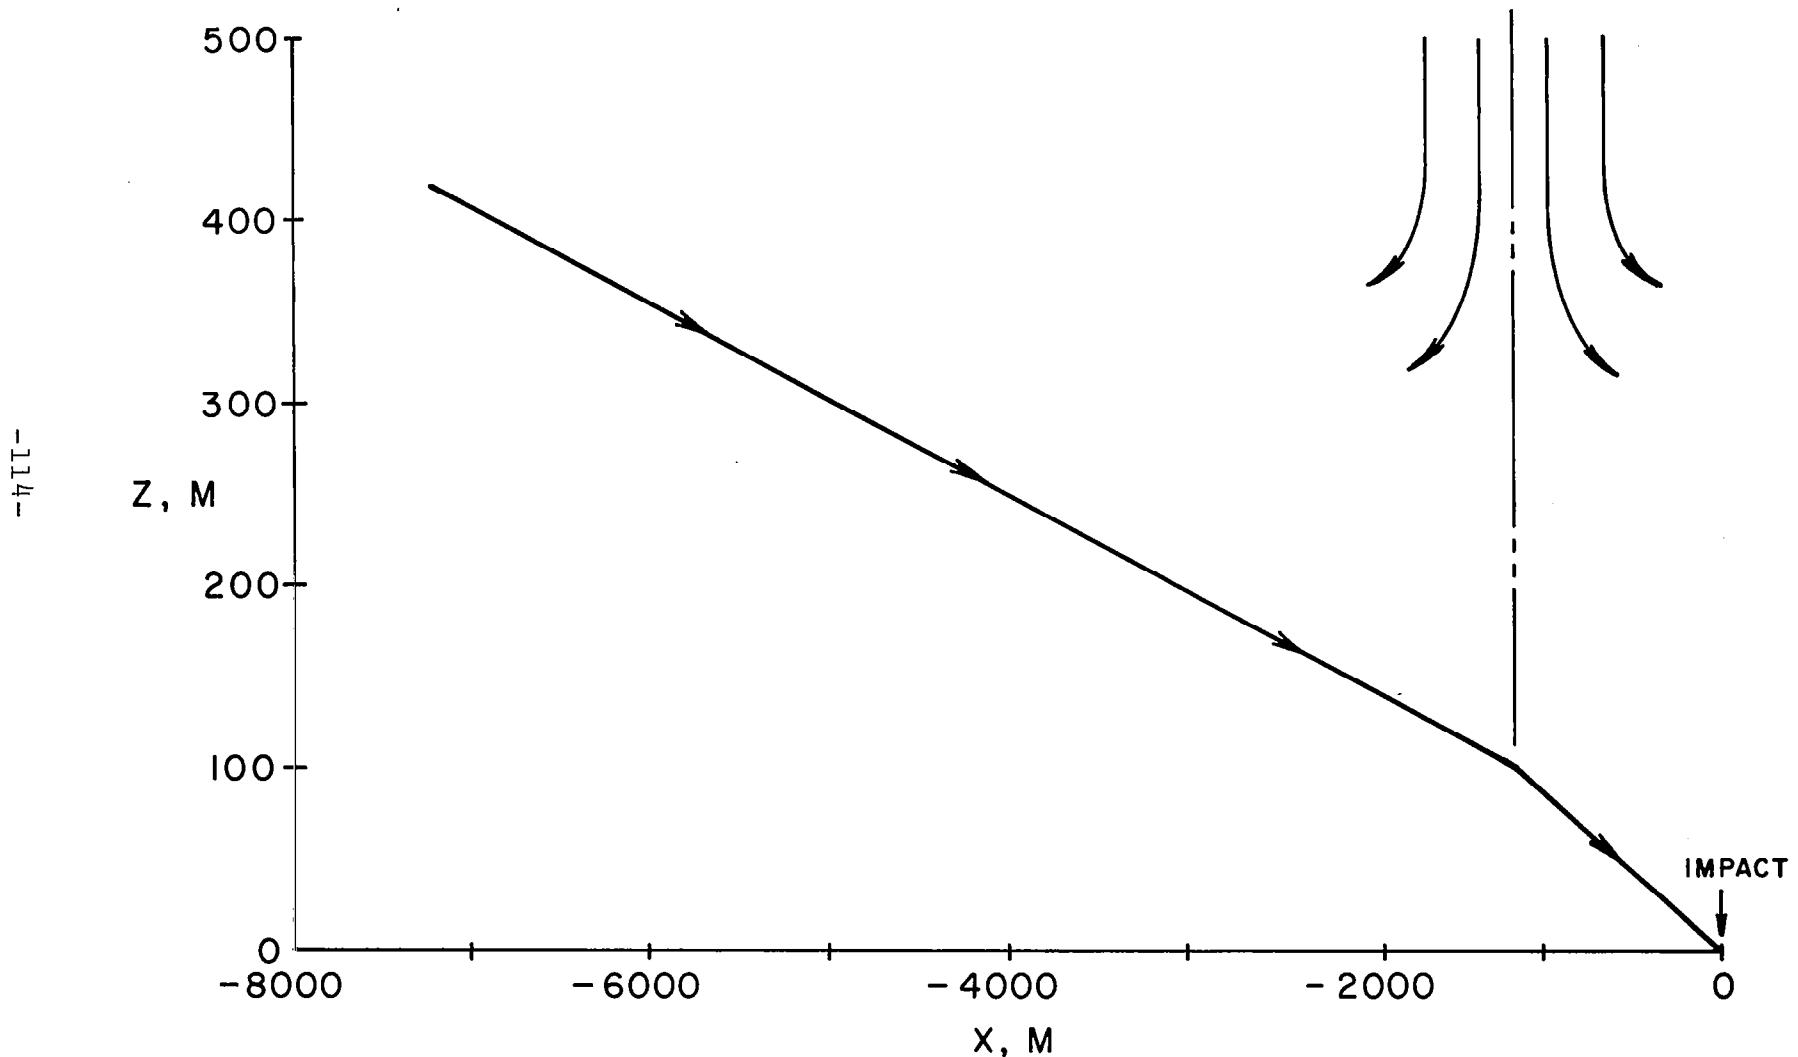
Figure 4.3.2. Approximate aircraft trajectory relative to storm cell and initial point of impact for Chattanooga, Tenn., November 27, 1973 accident.

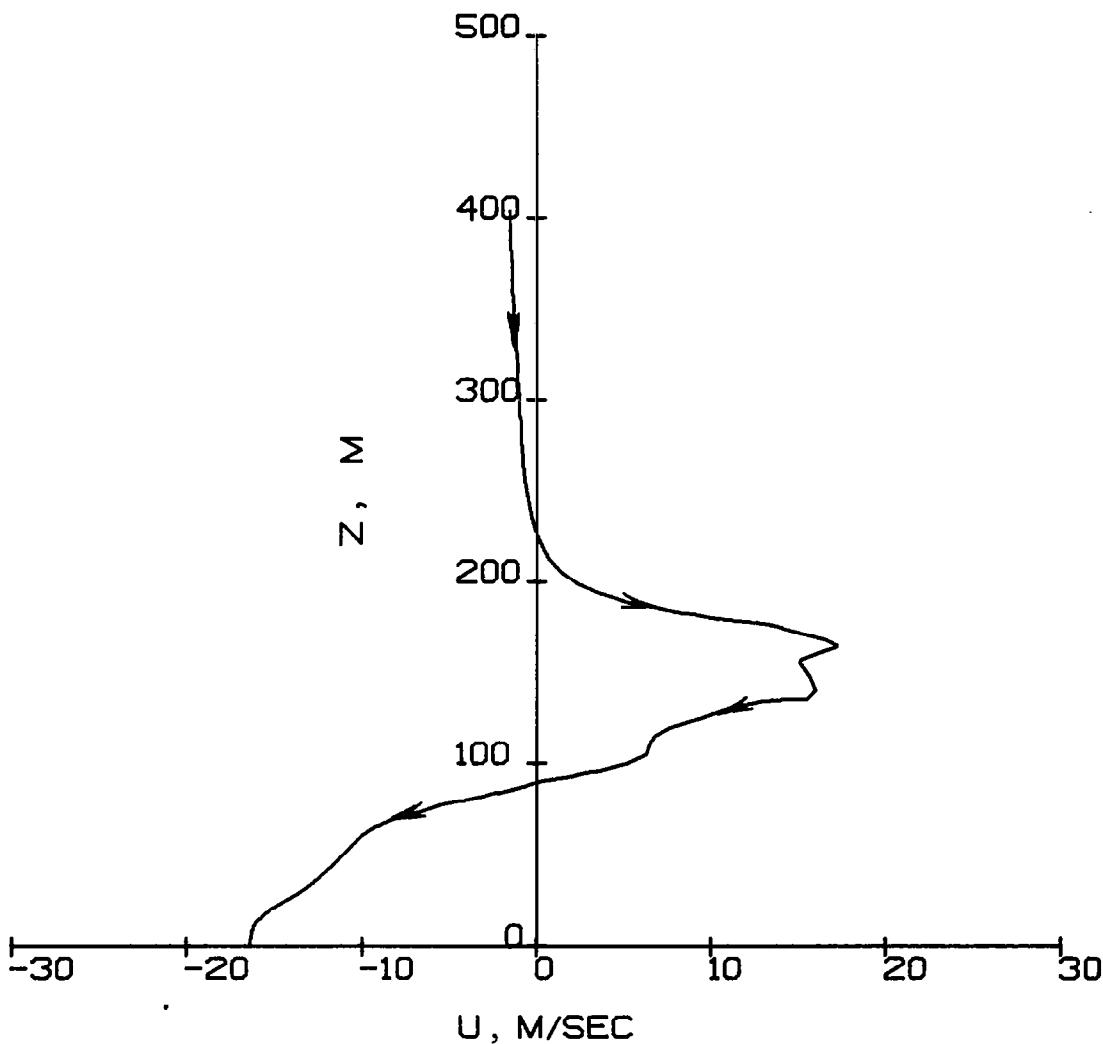
Figure 4.3.3. Altitude profile of mean wind velocity component parallel to runway (+U, tailwind) for Chattanooga, Tenn., November 27, 1973 accident.

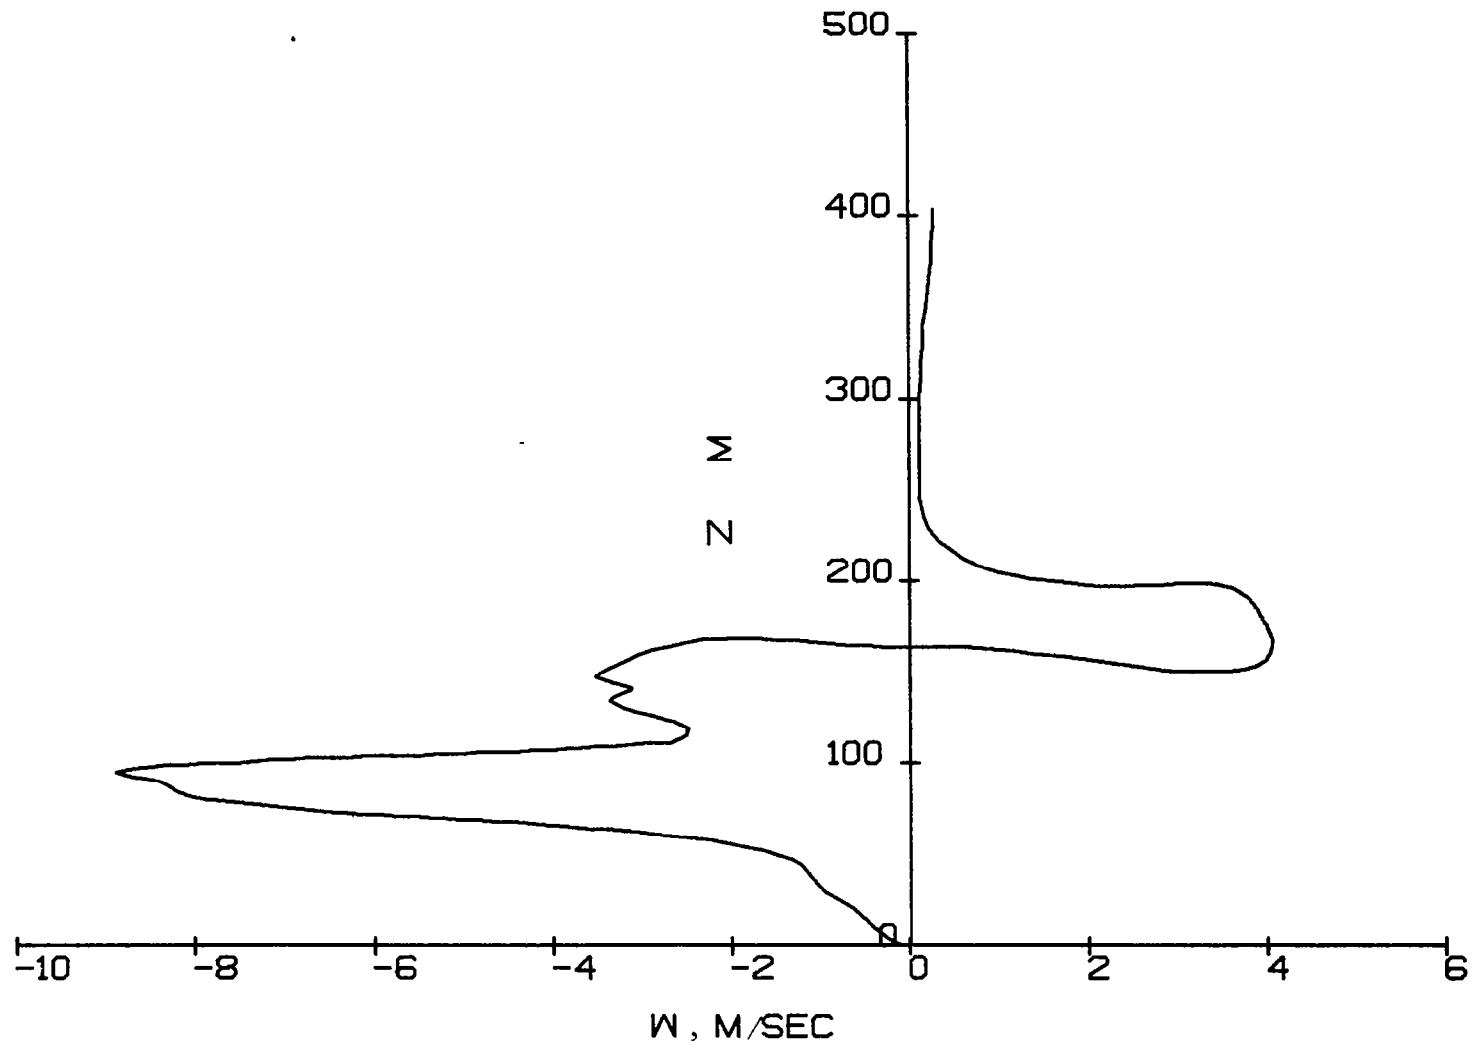
Figure 4.3.4. Altitude profile of mean wind vertical velocity component (+  $W$ , up) for Chattanooga, Tenn., November 27, 1973 accident.

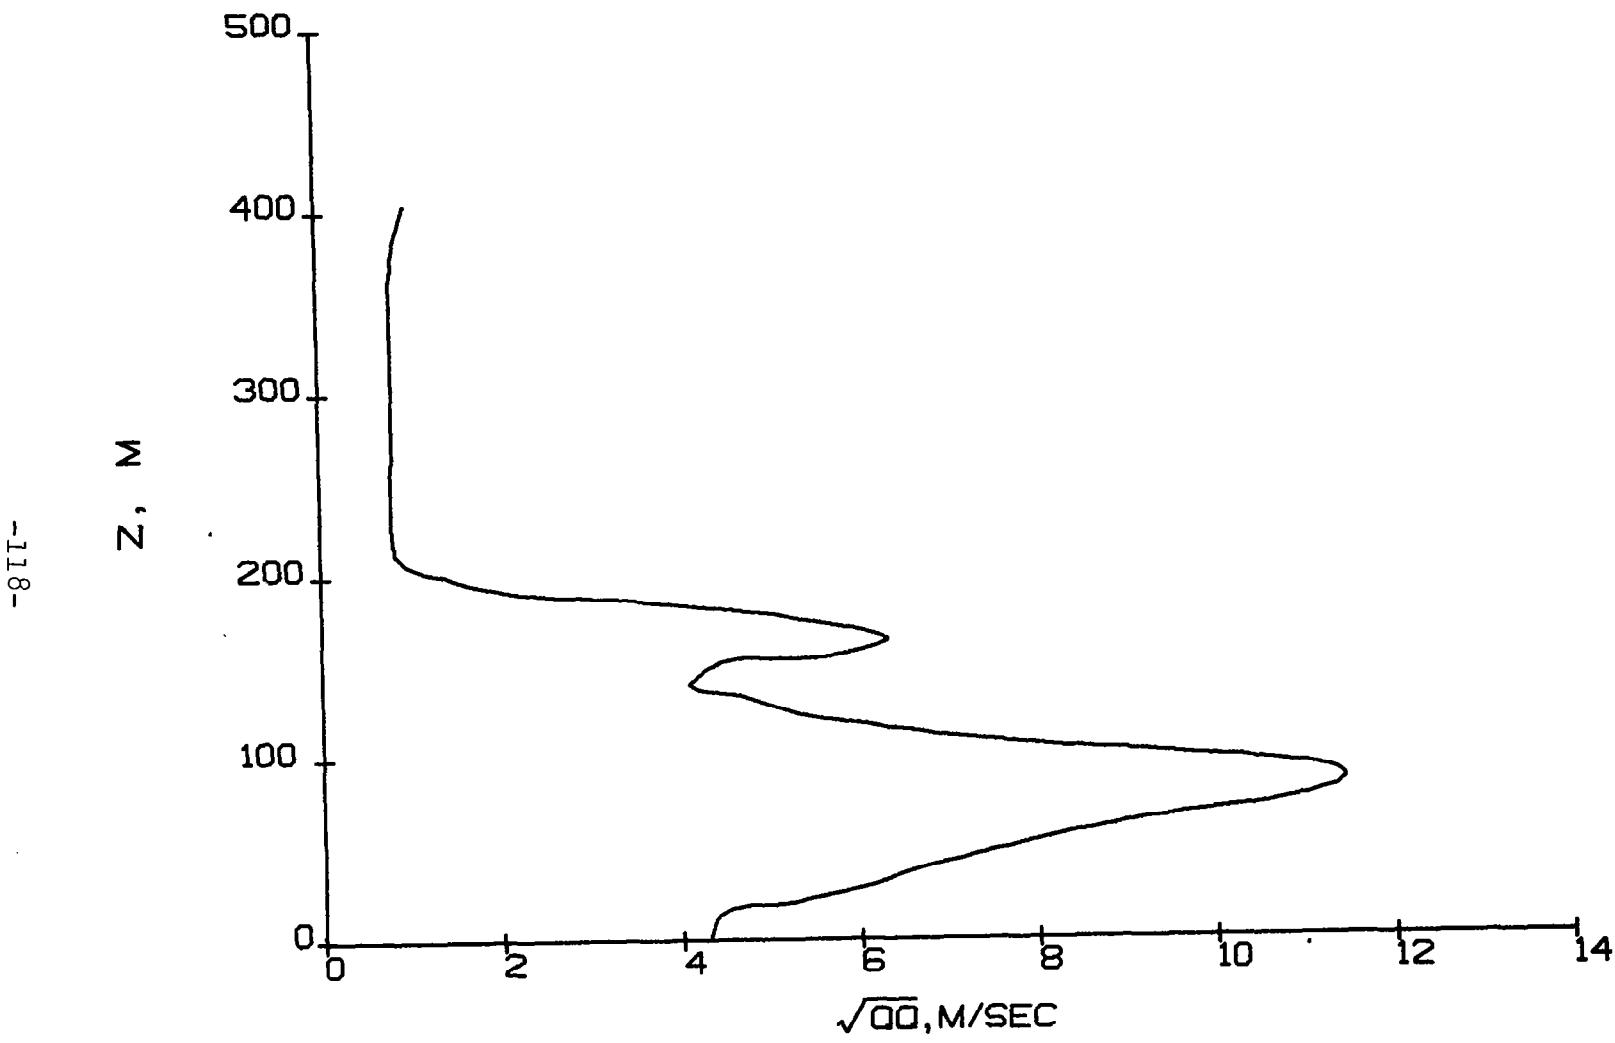
Figure 4.3.5. Altitude profile of variance of the total velocity for the Chattanooga, Tenn., November 27, 1973 accident.

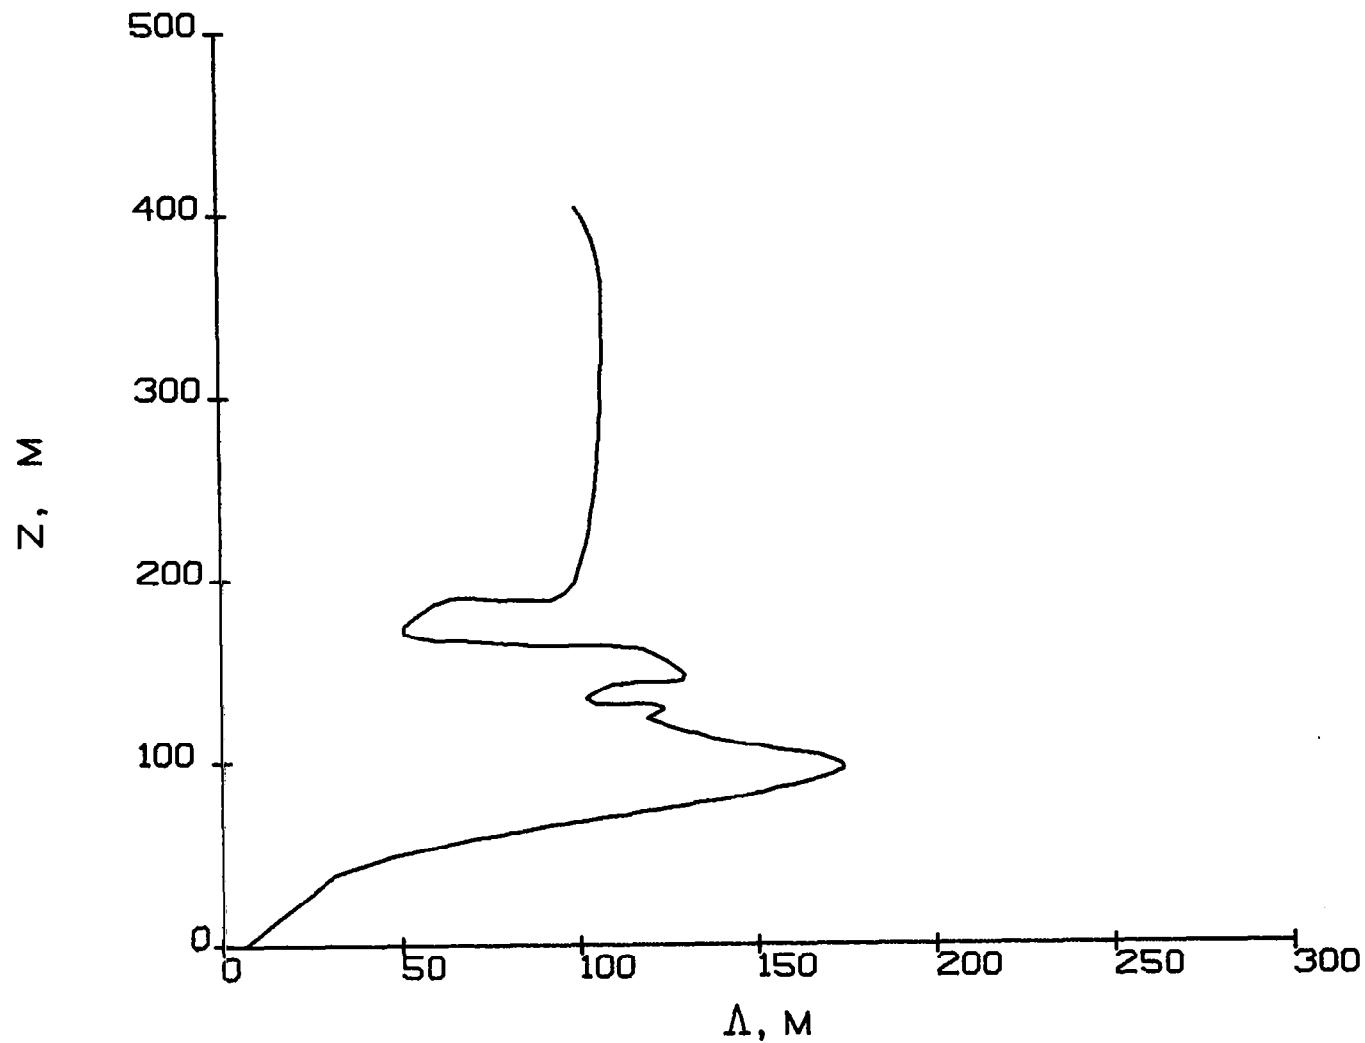
Figure 4.3.9. Altitude profile of scale of turbulence for Chattanooga, Tenn., November 27, 1973 accident.

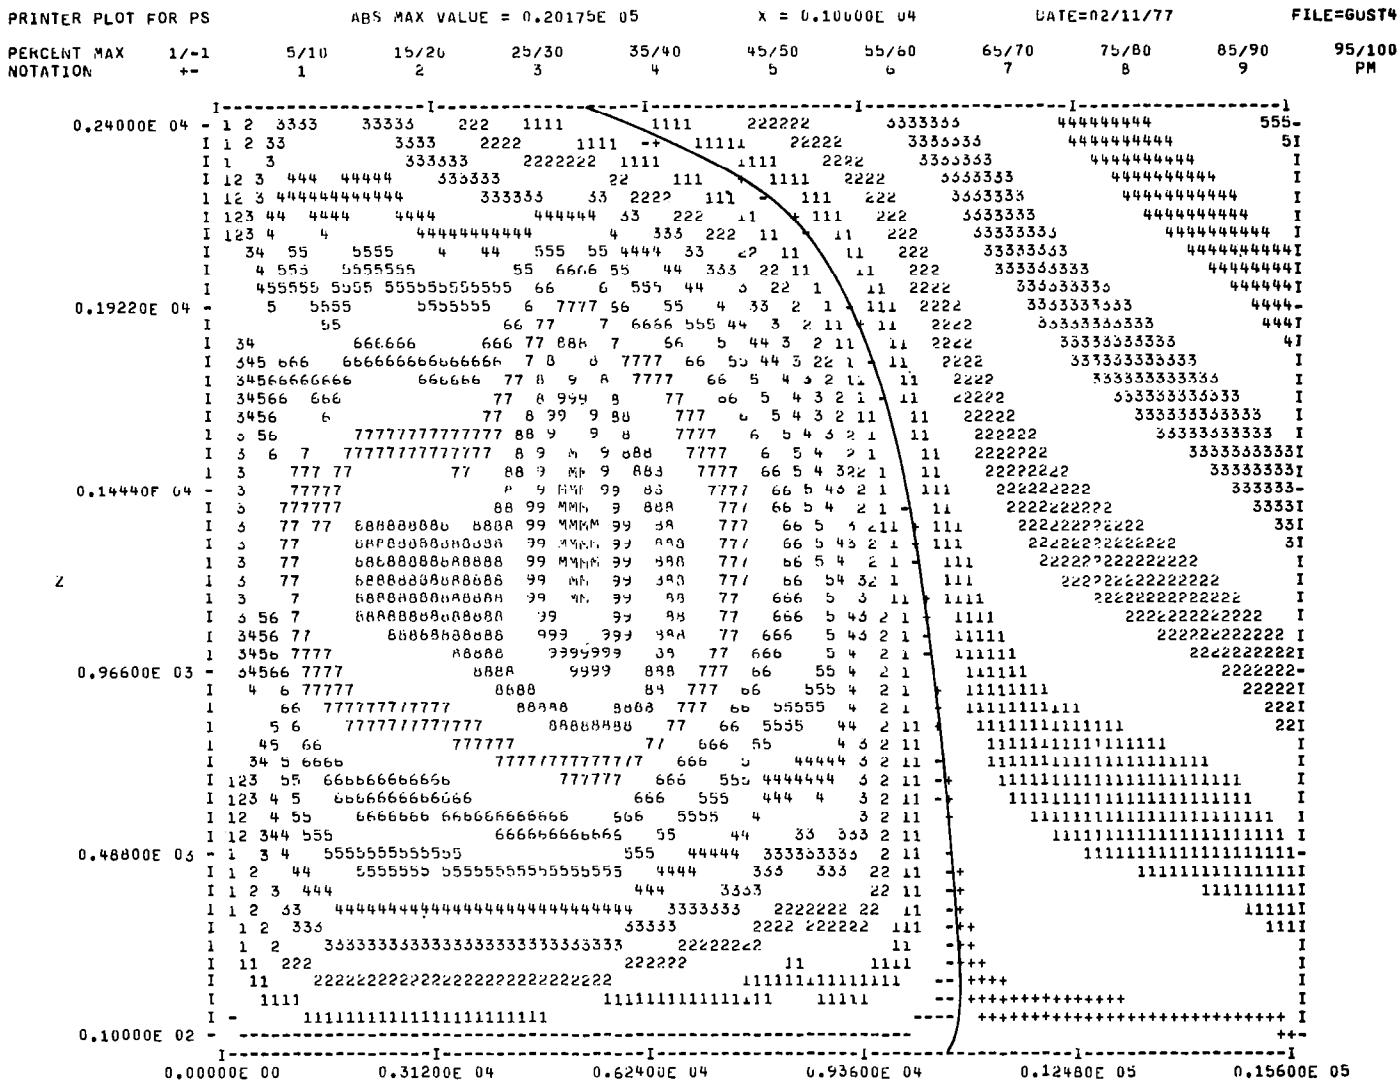
Figure 4.4.3. Normalized stream function contours as a function of z and y for a two-dimensional gust front with a 2000 m radius downdraft at t = 1000 sec. [See figure 2.3.2 for explanation of notation.]

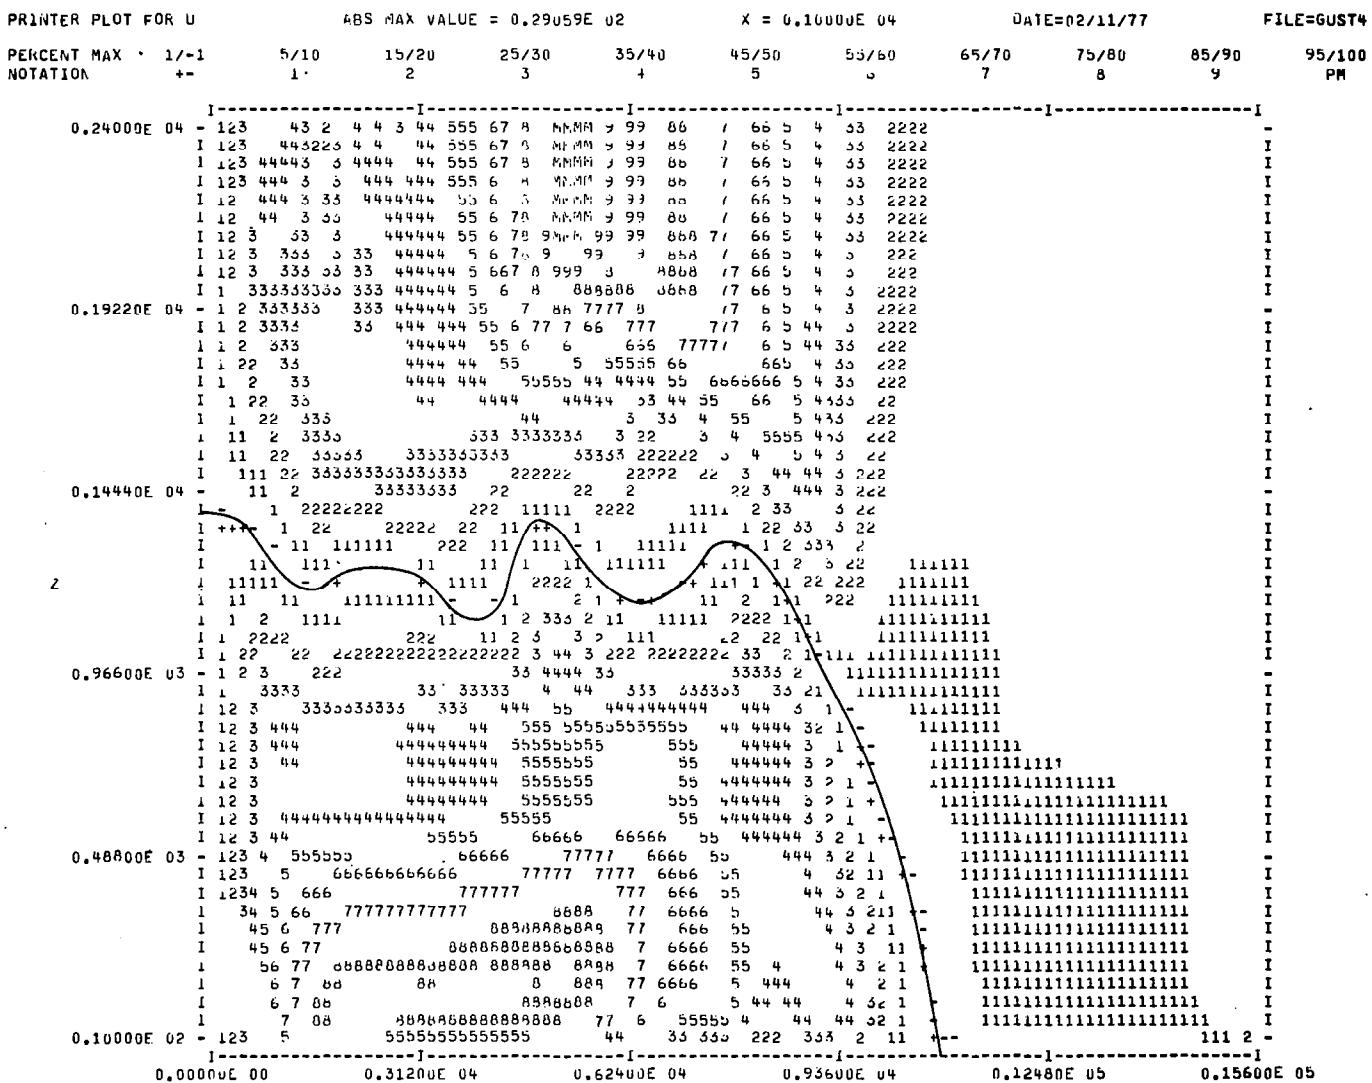
Figure 4.4.4. Normalized mean radial velocity contours as a function of  $z$  and  $y$  for a two-dimensional gust front with a 2000 m radius downdraft at  $t = 1000$  sec. [See figure 2.3.2 for explanation of notation.]

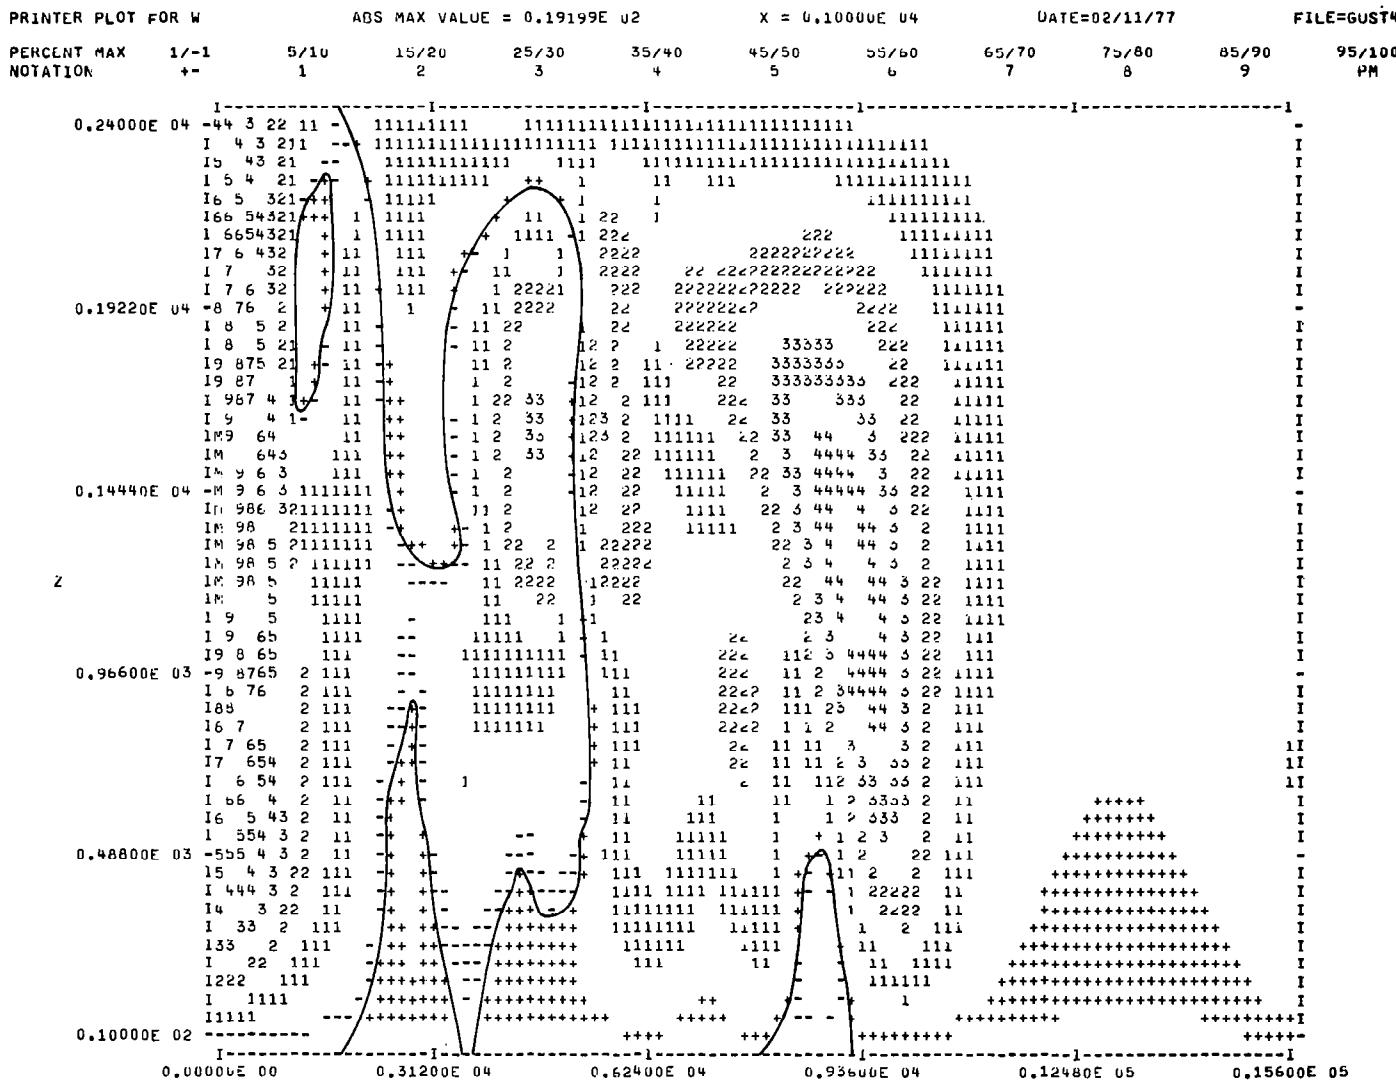
Figure 4.4.5. Normalized mean vertical velocity contours as a function of  $z$  and  $y$  for a two-dimensional gust front with a 2000 m radius downdraft at  $t = 1000$  sec. [See figure 2.3.2 for explanation of notation.]

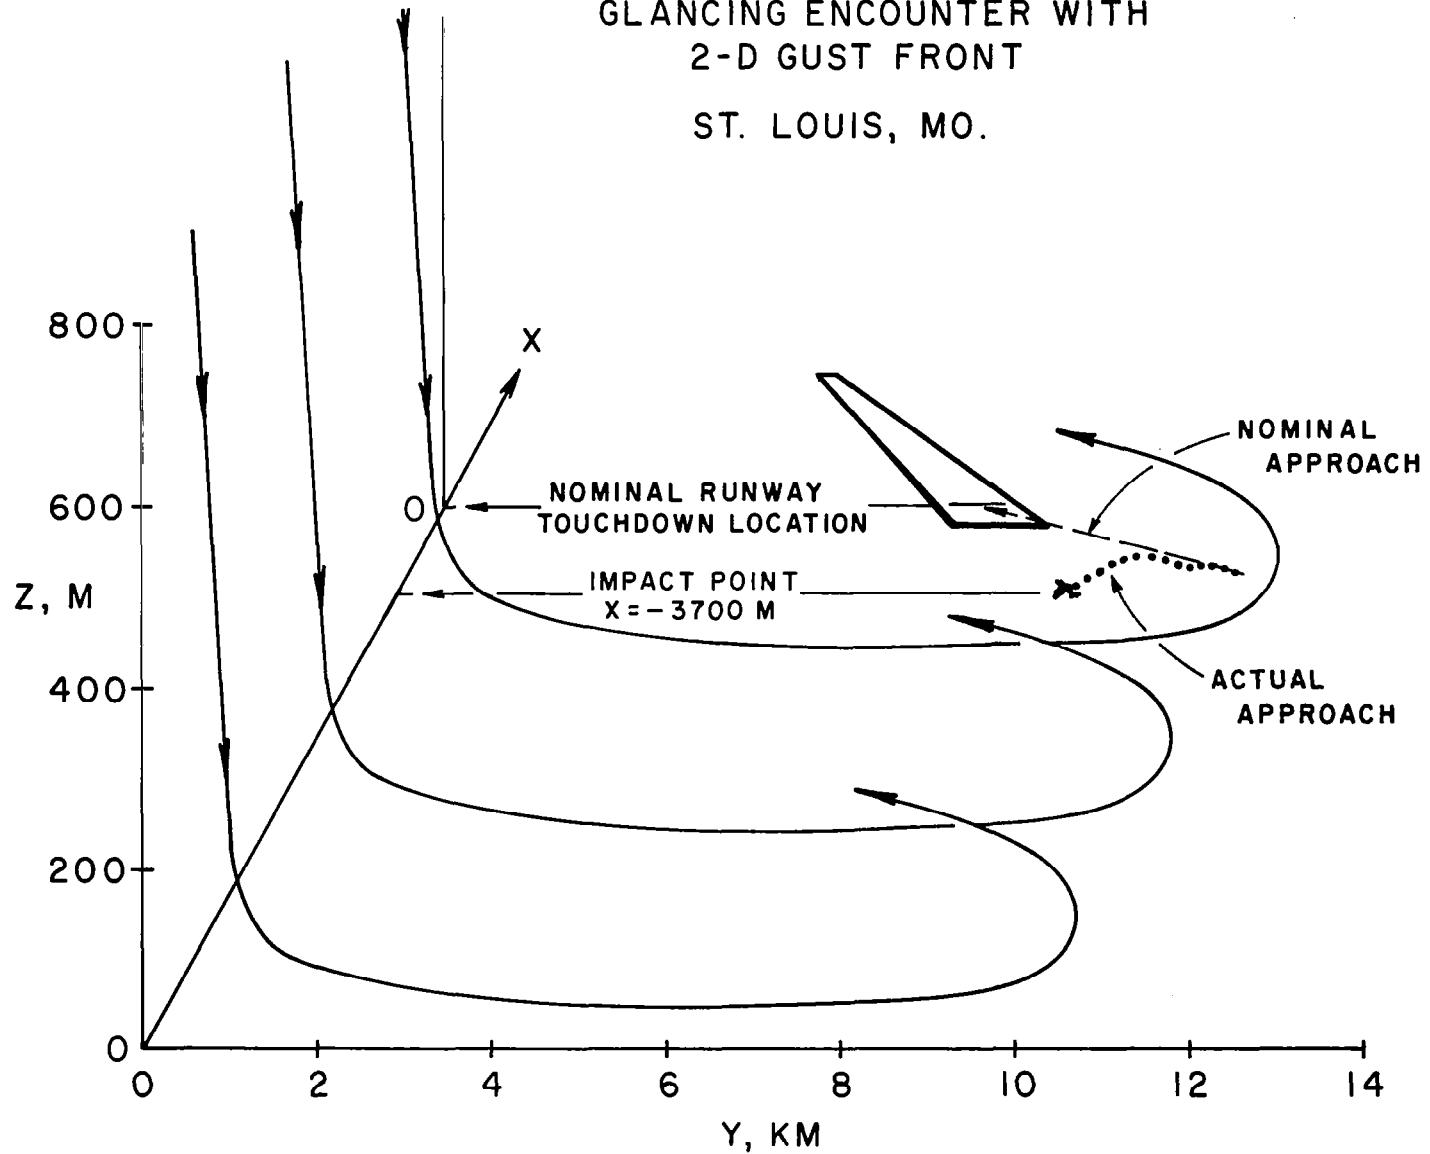
Figure 4.4.8. Aircraft-runway gust front orientation diagram for the St. Louis, Mo., July 23, 1973 accident.

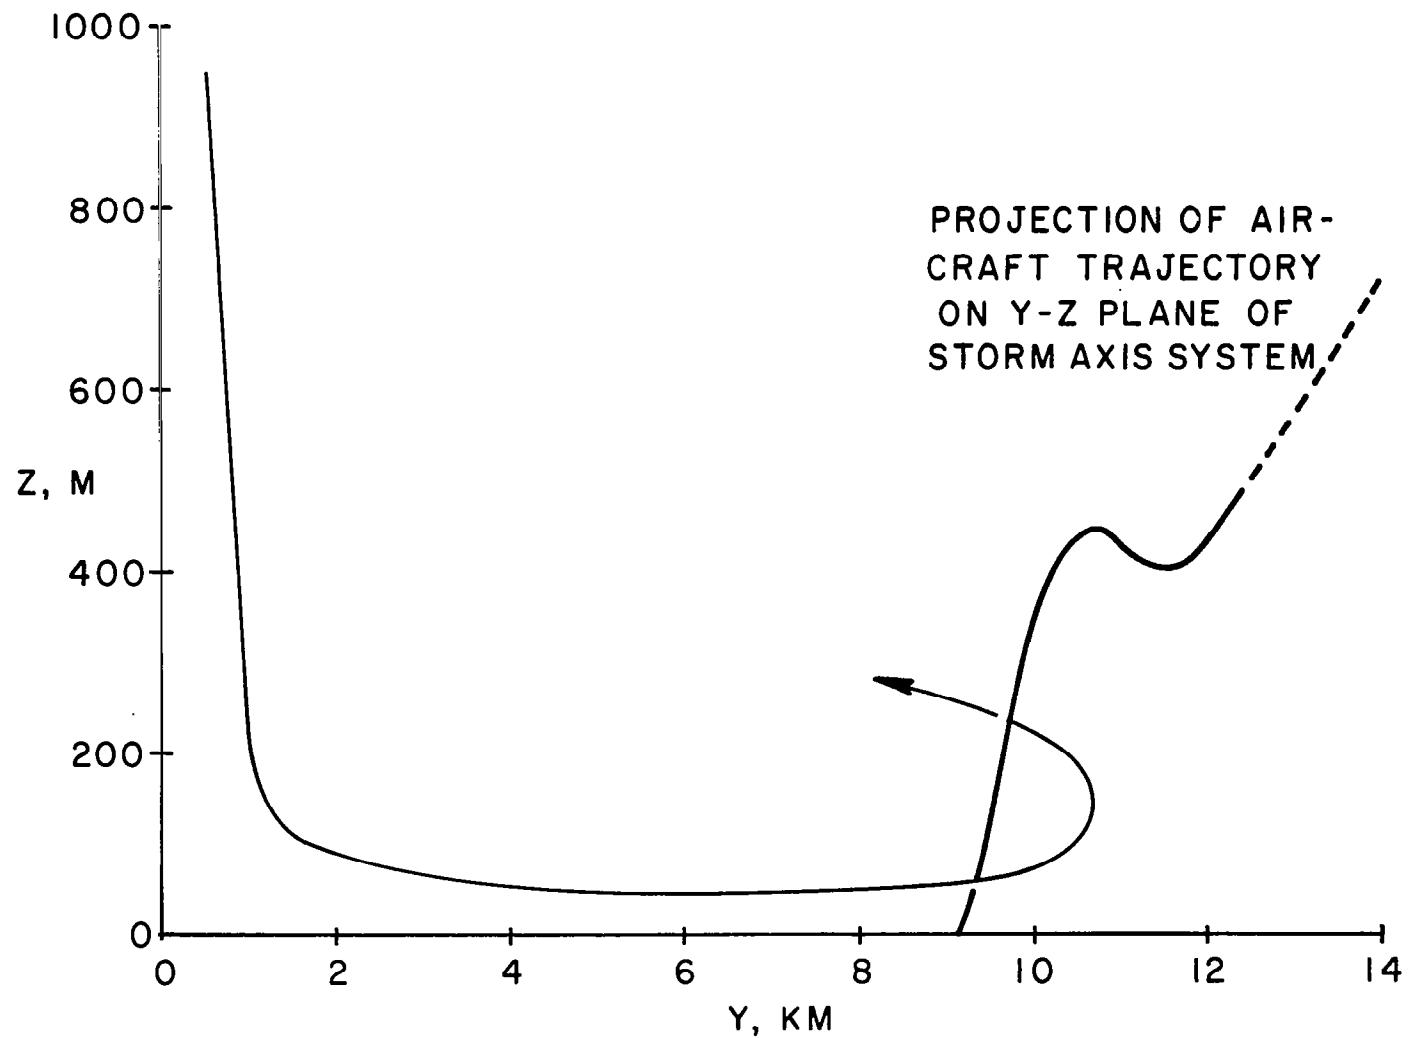
Figure 4.4.9. Projection of aircraft trajectory on the plane of the gust front for the St. Louis, Mo., July 23, 1973 accident.

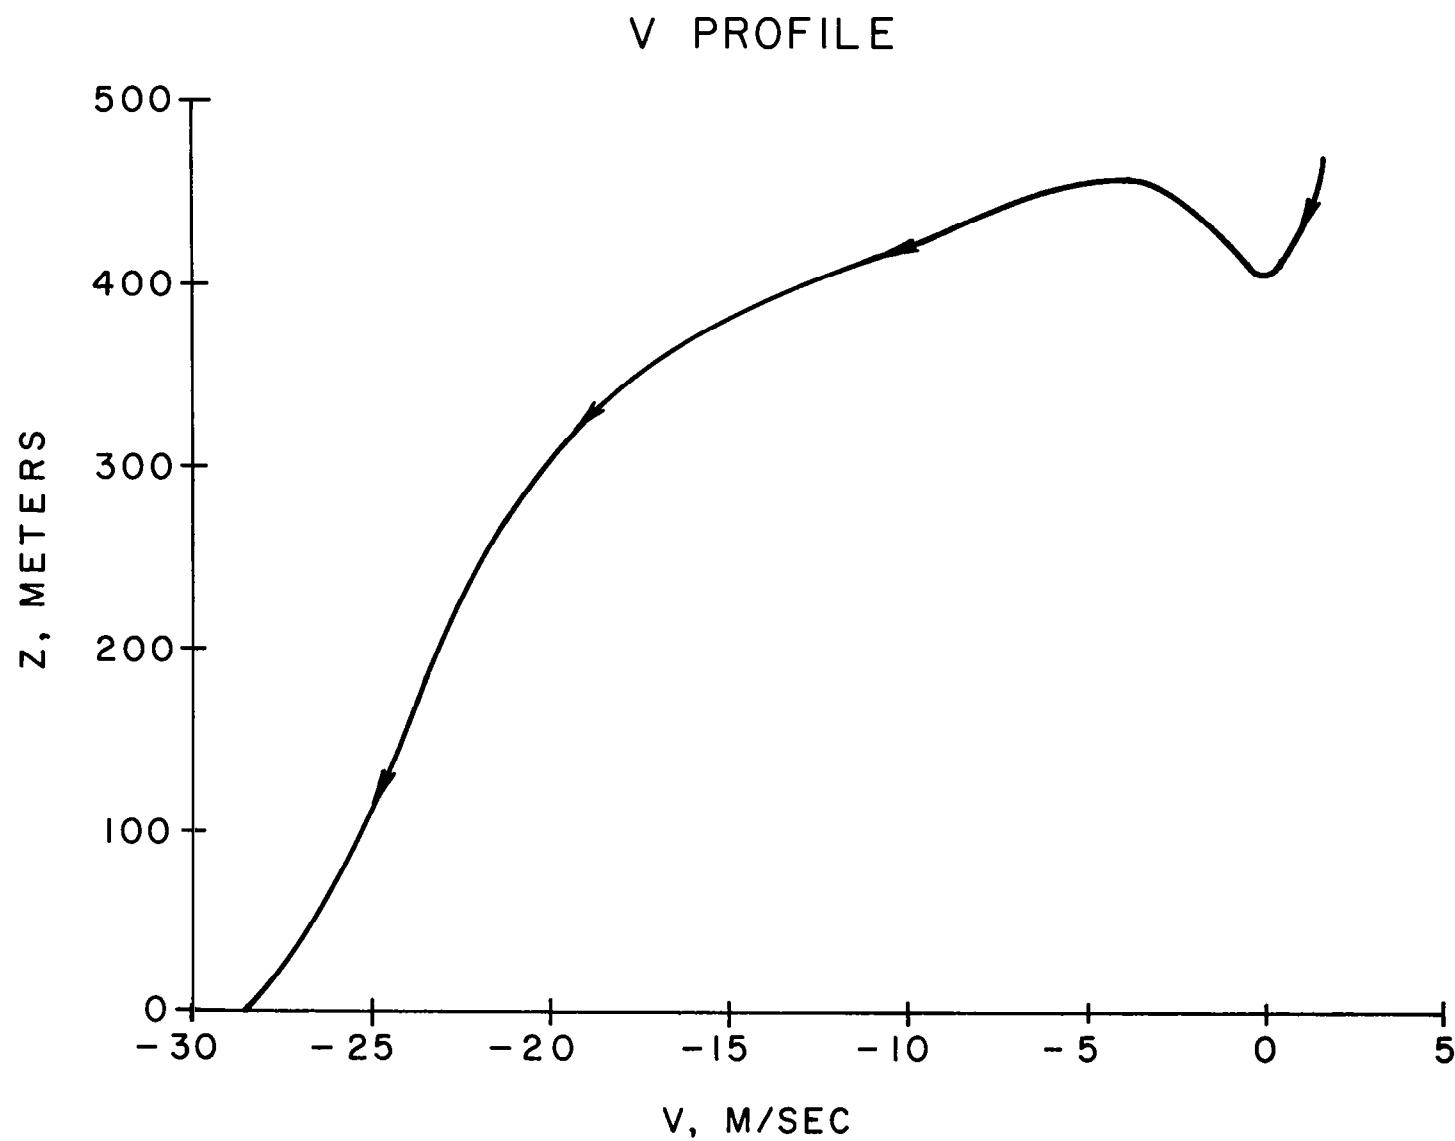
Figure 4.4.10. Altitude profile of horizontal mean wind velocity component along aircraft trajectory for the St. Louis, Mo., July 23, 1973 accident (+  $V$ , crosswind from right).

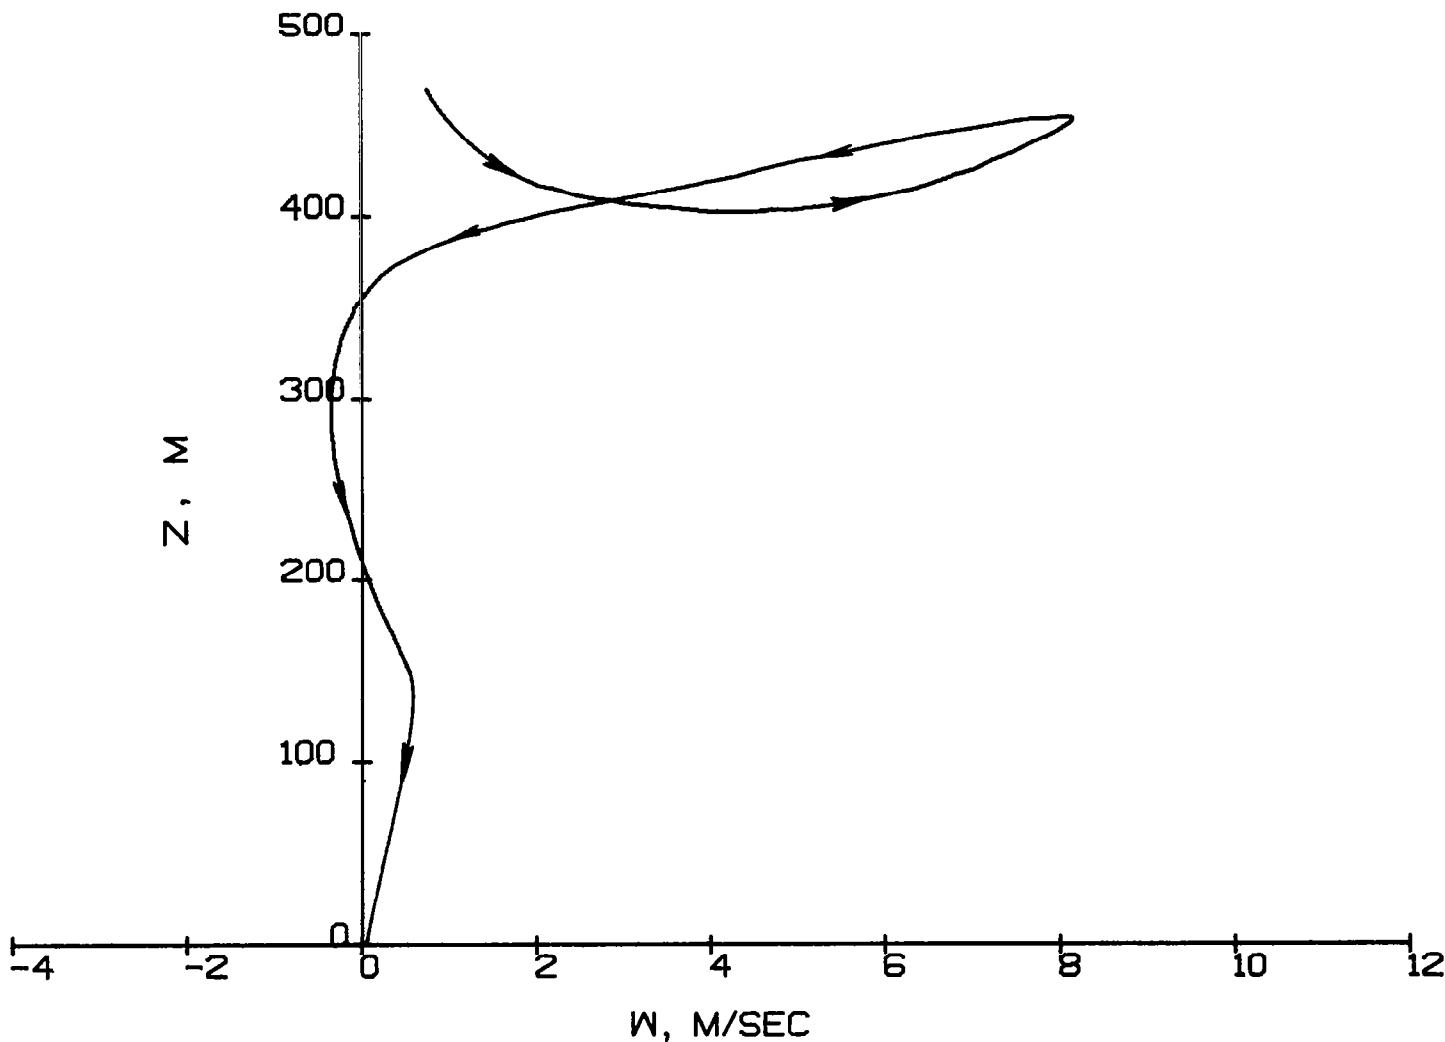
## UPDRAFT PROFILE

Figure 4.4.11. Altitude profile of vertical mean wind velocity component along aircraft trajectory for the St. Louis, Mo., July 23, 1973 accident, (+  $W$ , updraft).

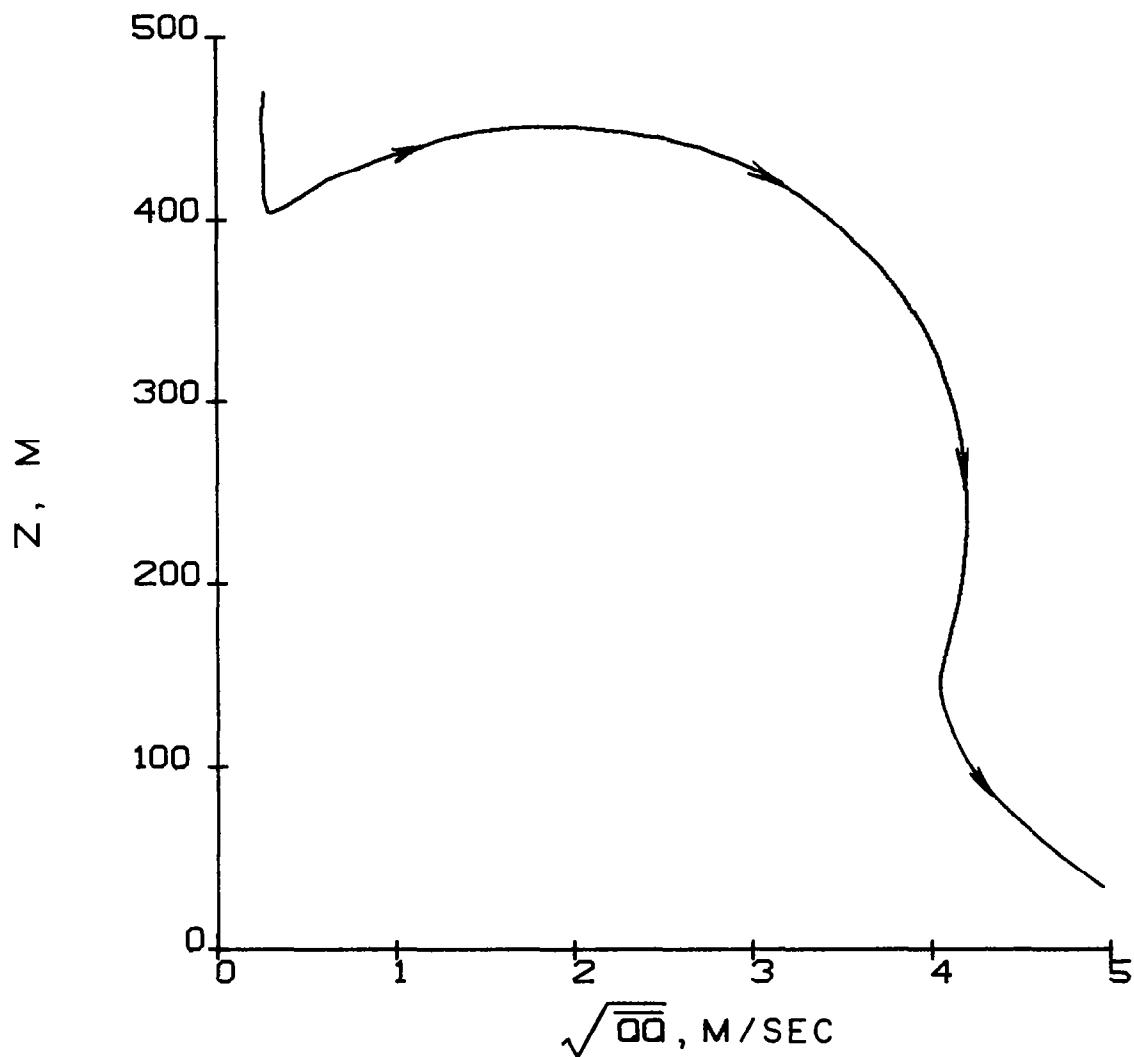
## QQ PROFILE

Figure 4.4.12. Altitude profile of variance of total velocity along aircraft trajectory for the St. Louis, Mo., July 23, 1973 accident.

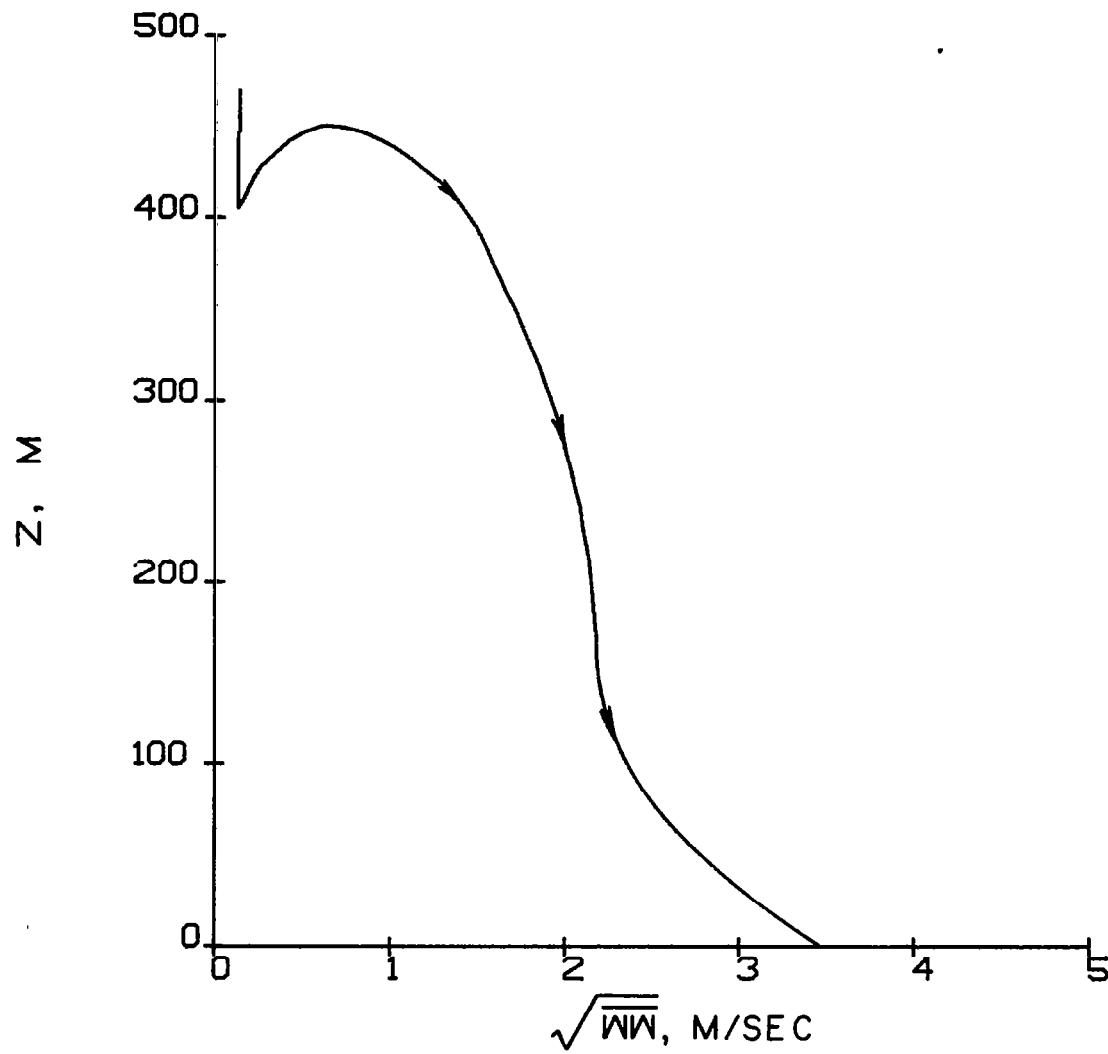
## MM PROFILE

Figure 4.4.15. Altitude profile of variance of the vertical wind along aircraft trajectory for the St. Louis, Mo., July 23, 1973 accident.

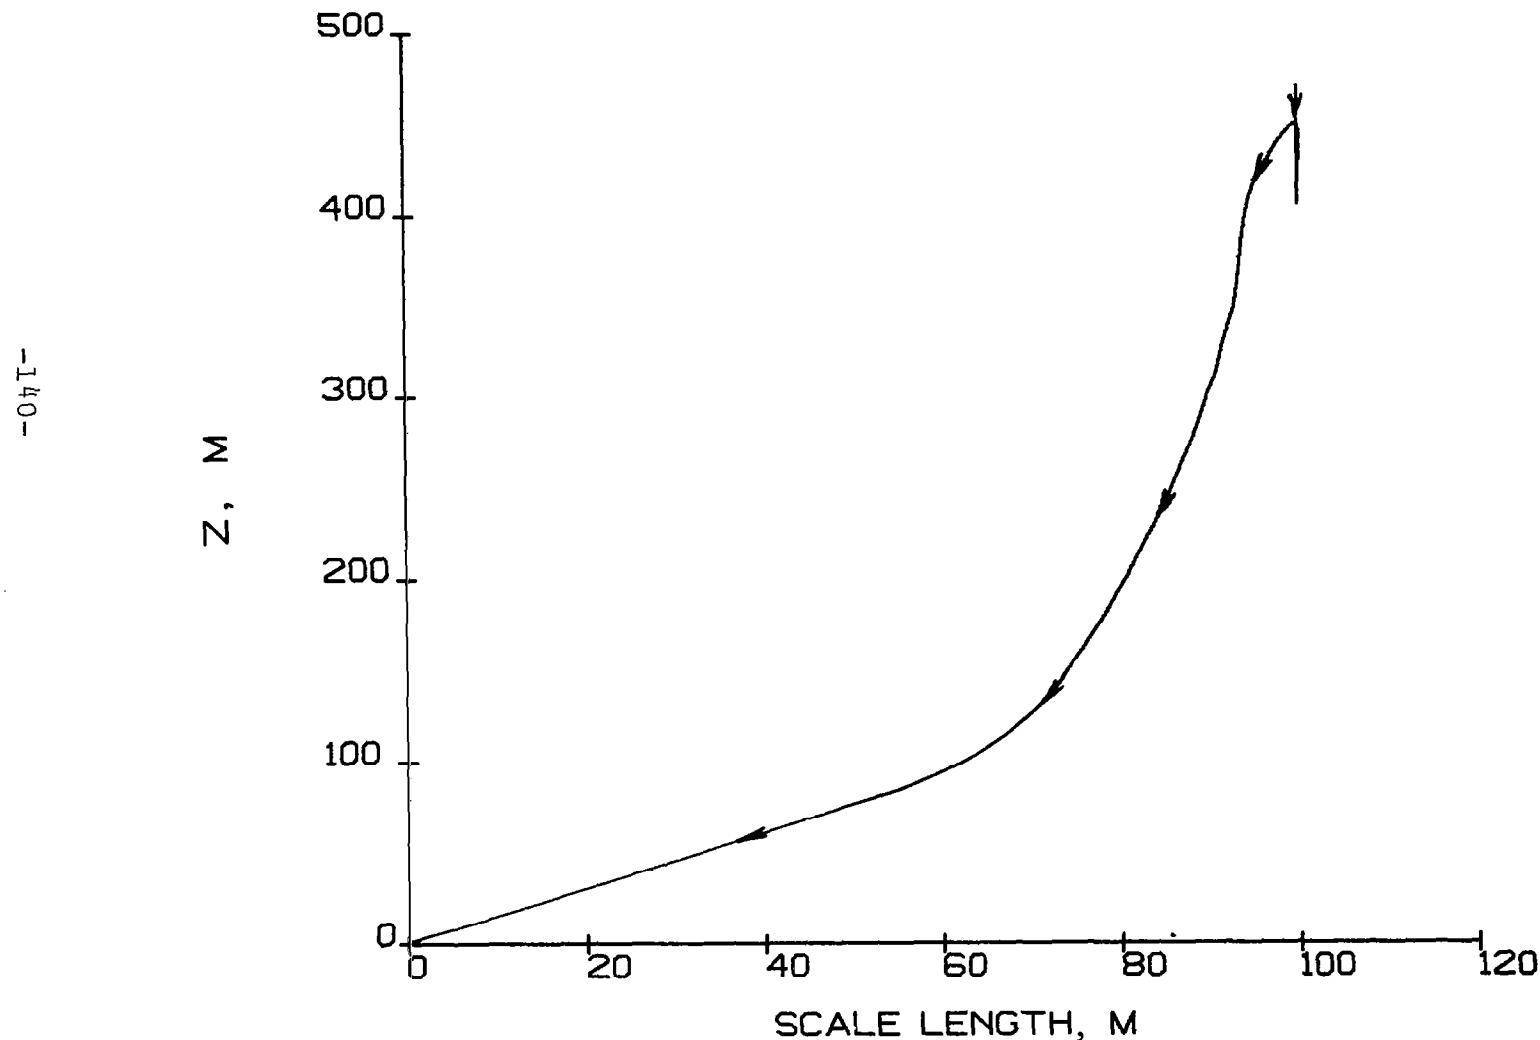
Figure 4.4.16. Altitude profile of scale of turbulence along aircraft trajectory for the St. Louis, Mo., July 23, 1973 accident.
